# Manhole Inspection Summary

Manhole # S21GG2006MH

**Location** Address: **1115 BRYN MAWR RD** Cross Street: **HARRINGTON RD**

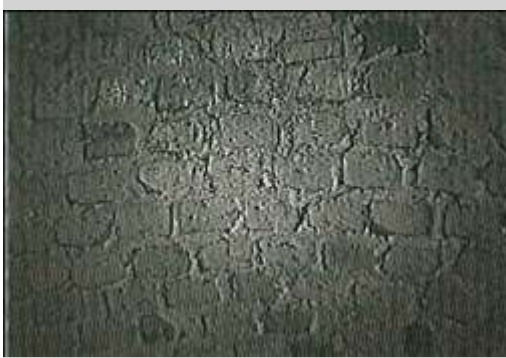
Defect

Barrel deterioration and infiltration.

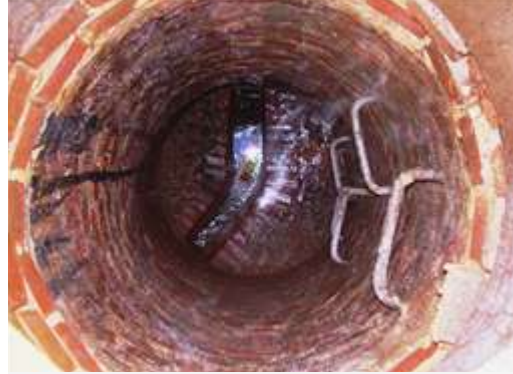
Top View

Adjustment loose brick, deterioration, and infiltration. Barrel infiltration. Evidence of surcharge - Bench debris.

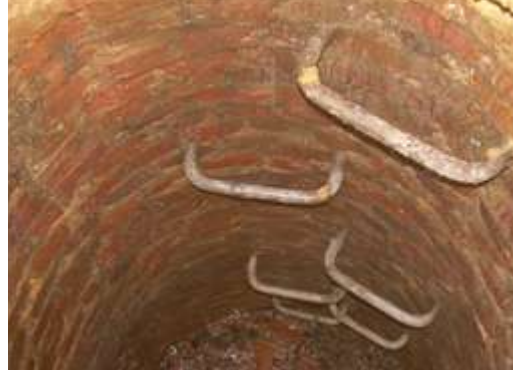
Defect

Adjustment deterioration and infiltration. Corbel and Barrel infiltration.

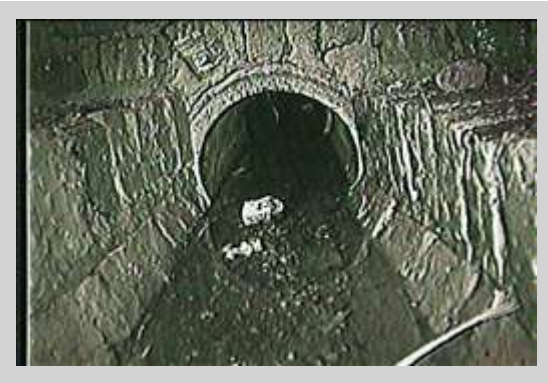
Pipe Out @ 12 O'Clock

Barrel deterioration and infiltration. Channel deterioration.

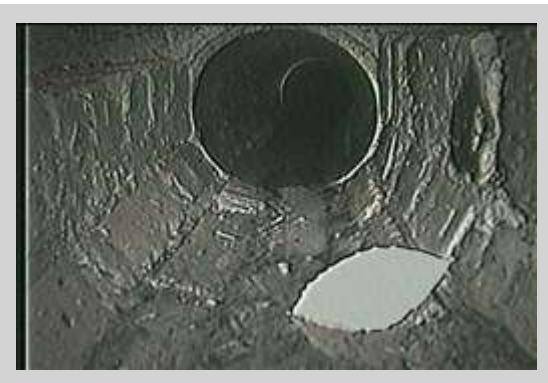
Pipe In @ 7 O'Clock

Channel deterioration.
